# 22 PRESERVATION BRIEFS

## The Preservation and Repair of Historic Stucco

Anne Grimmer

U.S. Department of the Interior  
National Park Service  
Preservation Assistance Division

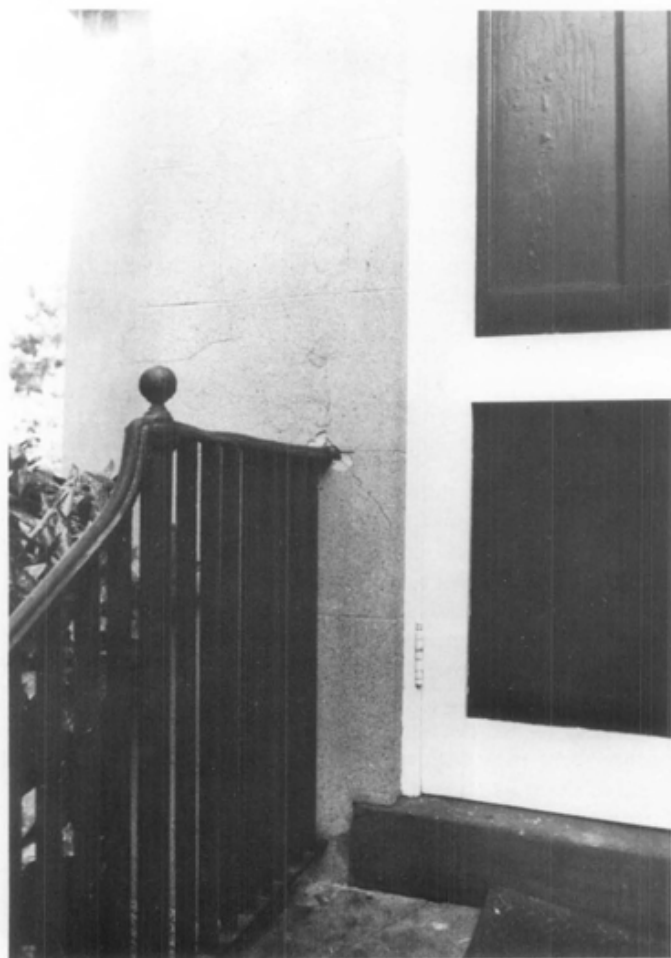
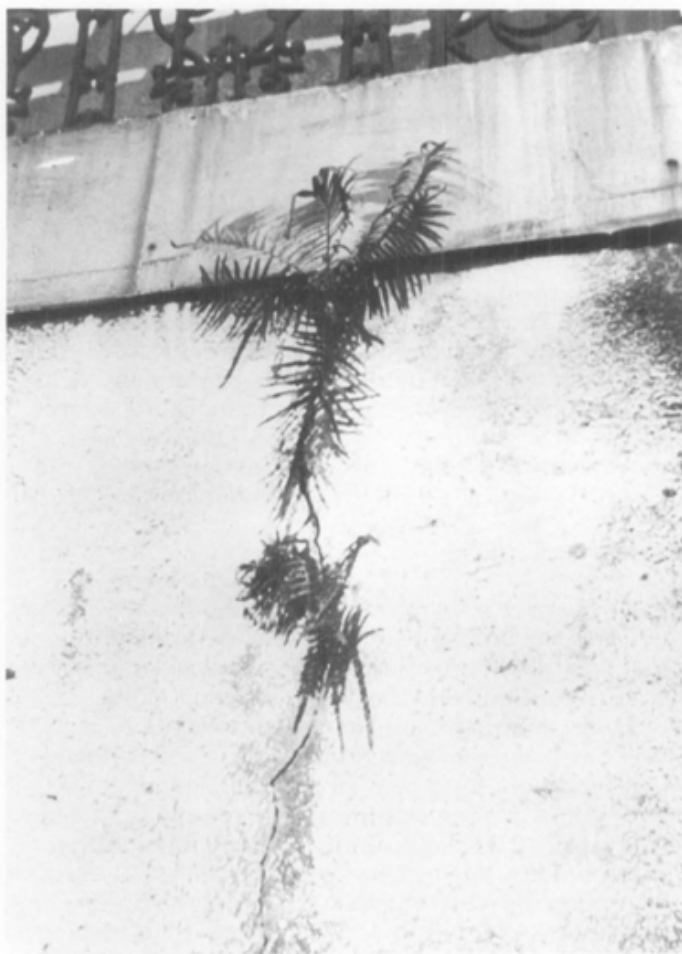
Fig. 12. (a) Water intrusion caused by rusting metal, or (b) plant growth left unattended will gradually enlarge these cracks, resulting in spalling, and eventually requiring extensive repair of the stucco. Photos: National Park Service Files.

repairs, external vibration caused by traffic or construction, or building settlement can also result in cracks which permit the entrance of water and cause the stucco to fail (Fig. 12).

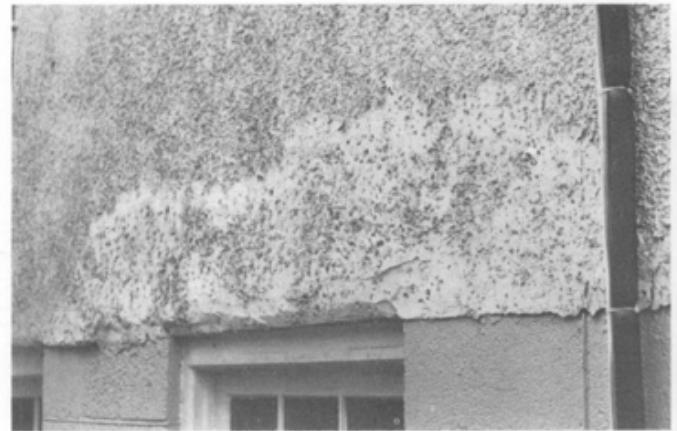
Fig. 14. This poorly executed patch is not the work of a professional plasterer. While it may serve to keep out water, it does not match the original surface, and is not an appropriate repair for historic stucco. Photo: Betsy Chittenden.

Once the extent of damage has been determined, a number of repair options may be considered. Small hairline cracks usually are not serious and may be sealed with a thin slurry coat consisting of the finish coat ingredients, or even with a coat of paint or white-wash. Commercially available caulking compounds are not suitable materials for patching hairline cracks. Because their consistency and texture is unlike that of stucco, they tend to weather differently, and attract more dirt; as a result, repairs made with caulking compounds may be highly visible, and unsightly (Fig. 13). Larger cracks will have to be cut out in preparation for more extensive repair. Most stucco repairs will require the skill and expertise of a professional plasterer (Fig. 14).

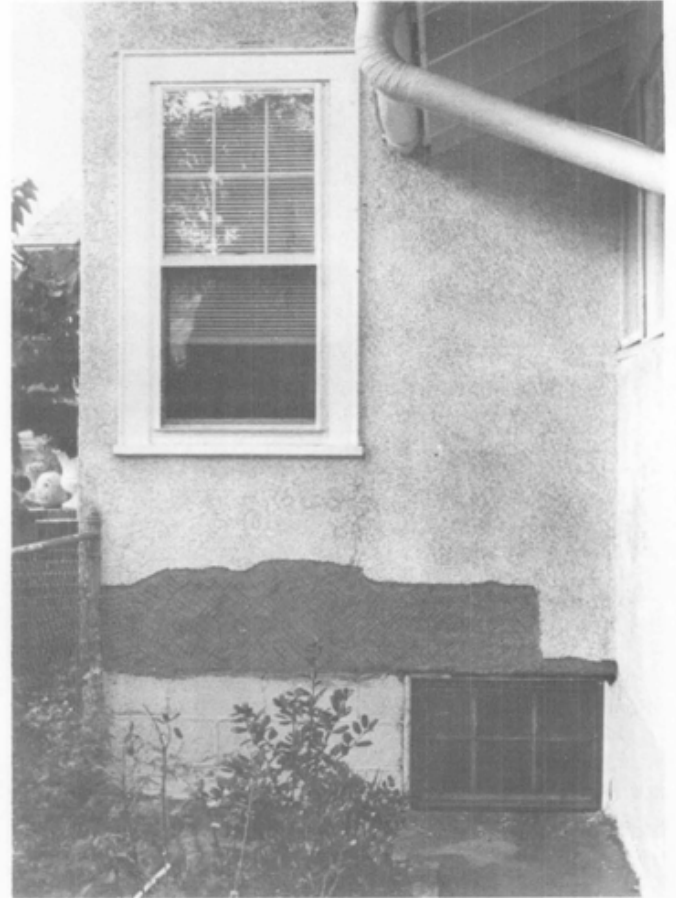
Fig. 15. (a) After reattaching any loose wood lath to the furring strips underneath, the area to be patched has been cleaned, the lath thoroughly wetted, and (b) the first coat of stucco has been applied and scratched to provide a key to hold the second layer of stucco. Photos: Betsy Chittenden.

bond between the stucco and substrate. The areas to be patched should be cleaned of all debris with a bristle brush, and all plant growth, dirt, loose paint, oil or grease should be removed (Fig. 15). If necessary, brick or stone mortar joints should then be raked out to a depth of approximately 5/8" to ensure a good bond between the substrate and the new stucco.

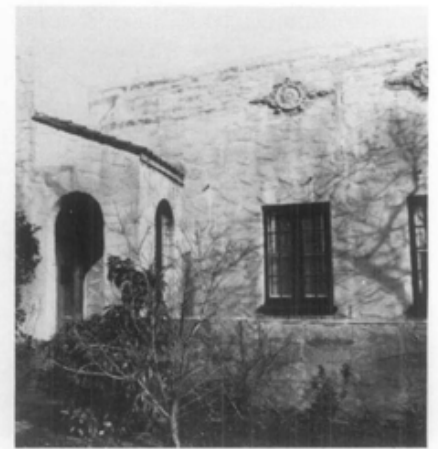
Most of the oldest stucco in the U.S. dating prior to the late-nineteenth century, will generally have a **smooth, troweled finish** (sometimes called a **sand or float finish**), possibly scored to resemble ashlar masonry units. Scoring may be incised to simulate masonry joints, the scored lines may be emphasized by black or white penciling, or the lines may simply be drawn or painted on the surface of the stucco. In some regions, at least as early as the first decades of the nineteenth century, it was not uncommon to use a **roughcast finish** on the foundation or base of an otherwise **smooth-surfaced** building (Fig. a). **Roughcast** was also used as an overall stucco finish for some outbuildings, and other less important types of structures.

A wide variety of decorative surface textures may be found on revival style stucco buildings, particularly residential architecture. These styles evolved in the late-nineteenth century and peaked in popularity in the early decades of the twentieth century. Frank Lloyd Wright favored a **smooth finish** stucco, which was imitated on much of the Prairie style architecture inspired by his work. Some of the more picturesque surface textures include: **English Cottage** or **English Cotswold finish**; **sponge finish** (Fig. b); **fan texture**; **adobe finish** (Fig. c), and **Spanish or Italian**

The most common early-twentieth century stucco finishes are often found on bungalow-style houses, and include: **spatter** or **spatterdash** (sometimes called **roughcast**, **harling**, or **wetdash**), and **pebbledash** or **drydash**. The **spatterdash** finish is applied by throwing the stucco mortar against the wall using a whisk broom or a stiff fiber brush, and it requires considerable skill on the part of the plasterer to achieve a consistently rough wall surface. The mortar used to obtain this texture is usually composed simply of a regular sand, lime, and cement mortar, although it may sometimes contain small pebbles or crushed stone aggregate, which replaces one-half the normal sand content. The **pebbledash** or **drydash finish** is accomplished manually by the plasterer throwing or "dashing" dry pebbles (about 1/8" to 1/4" in size), onto a coat of stucco freshly applied by another plasterer. The pebbles must be thrown at the wall with a scoop with sufficient force and skill that they will stick to the stuccoed wall. A more even or uniform surface can be achieved by patting the stones down with a wooden float. This finish may also be created using a texturing machine (Figs. d-f illustrate 3 versions of this finish. Photos: National Park Service Files).
